Harrogate case study

The latest refurbishment project

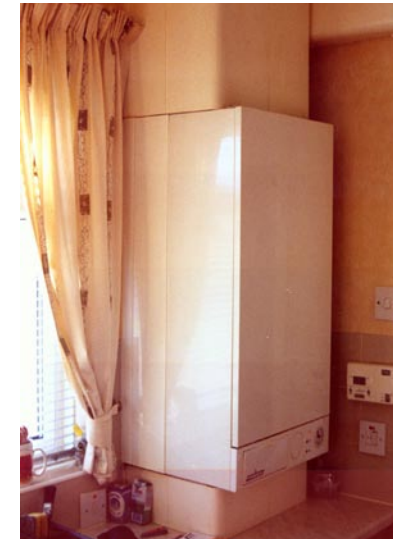
▲ The condensing boiler in one house within the scheme

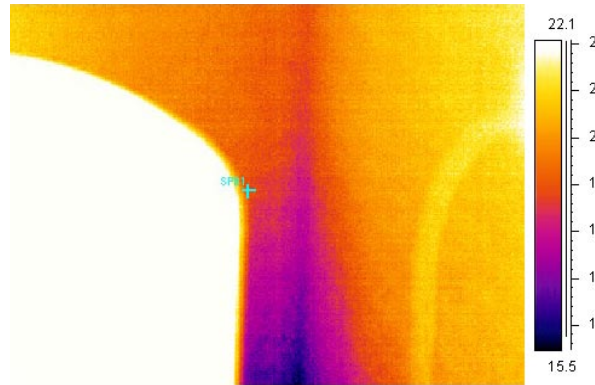
Infrared thermograms revealed that at ground floor level, the insides of the walls were at reduced temperature up to about half a metre above floor level, suggesting that there was significant thermal bridging at the wall-floor junction. Following discussion with a member of staff at the Borough Council it was found that the reason for the low wall temperatures close to ground level was that it was not practicable to run the external insulation all the way down to ground level and there was an area at the bottom of the wall which could not practicably be covered.

▲ A thermal image of a wall-wall junction behind a TV set. There is a relatively slight drop in temperature at the wall-wall junction, but there is a noticeable drop in temperature at the wall-floor junction. The white area on the left side of the photograph is an image of the TV-set, while the centre of the picture shows a relatively cold area at the wall-wall junction, particularly at or close to floor level. A photograph taken from a similar position is shown below:

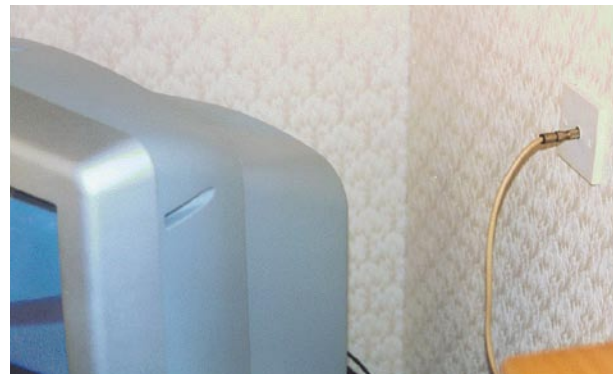
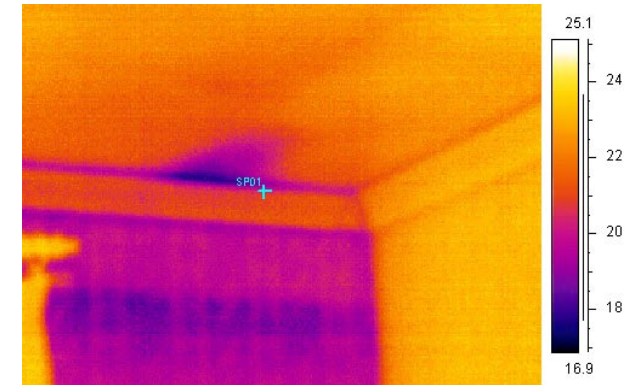
▲ There are a very small number of minor ceiling defects where the temperature is lowered, however in general this is the exception rather than the rule among the refurbished housing which was examined. The number and scale of ceiling defects suggests that the insulation on the walls and roofs is well-fitted and performing satisfactorily.

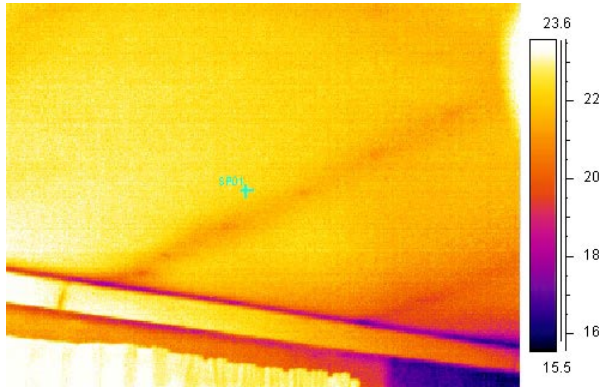
▲ A typical thermal image of a ceiling above a window. The temperature dip due to ceiling joists is visible. There is only a relatively small temperature drop at the lintel and wall-ceiling junction

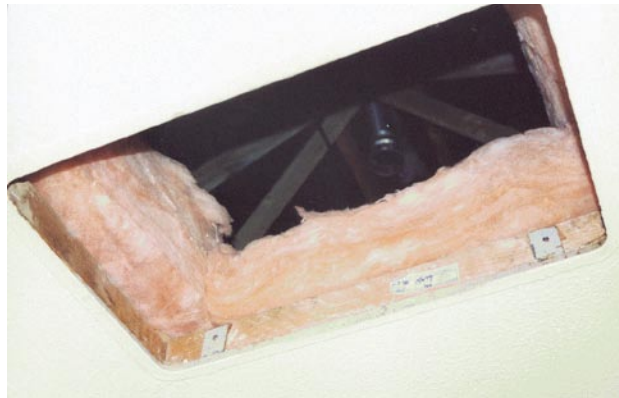
▲ A loft access hatch, showing the loft insulation after refurbishment, showing that the insulation fills the loft space and that there is no significant thermal bridging at the loft hatch

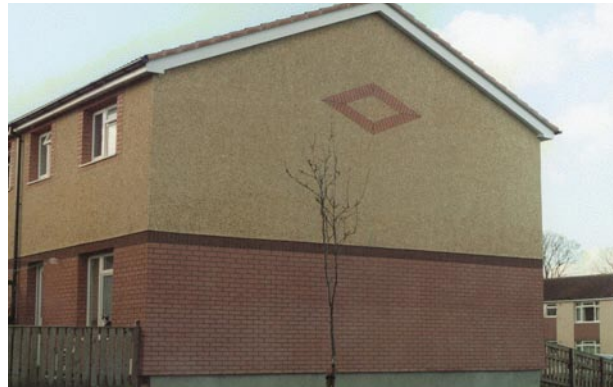
▲ An image of a gable wall, showing how it was not always practicable to extend the external wall insulation down to ground level. In this example, there is a gap of at least 300 mm between the ground level and the bottom of the external wall insulation

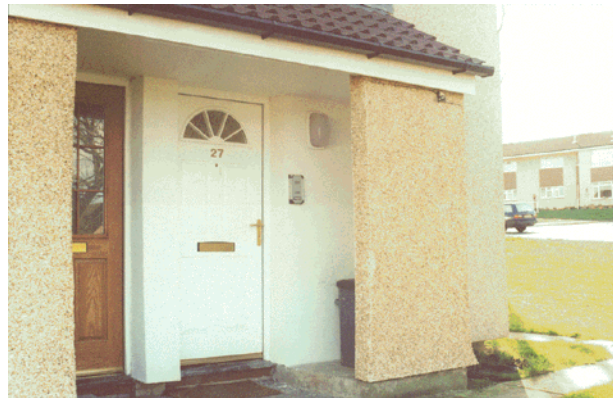
▲ The entrance to one of the houses, showing the external wall insulation taken almost to ground level. External insulation is also applied between the doors of the two adjacent dwellings
