Thermographic Inspection of
the Masonry and Hemp Houses
– Haverhill, Suffolk

Client Report Number
212020

17 April 2003

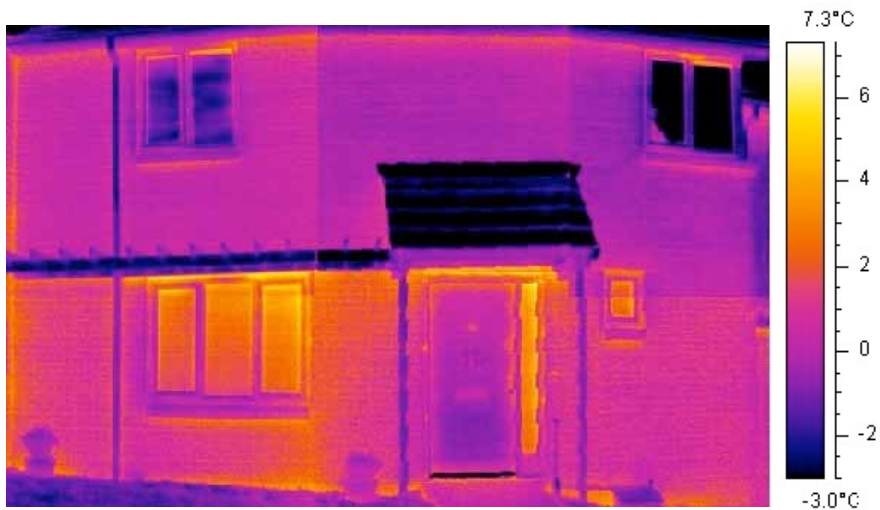
Figure 2: Thermographic image which represents the front elevation of the Masonry House as shown in Figure 1: Colour graduation represents temperature scale of -3°C to 7.3°C .

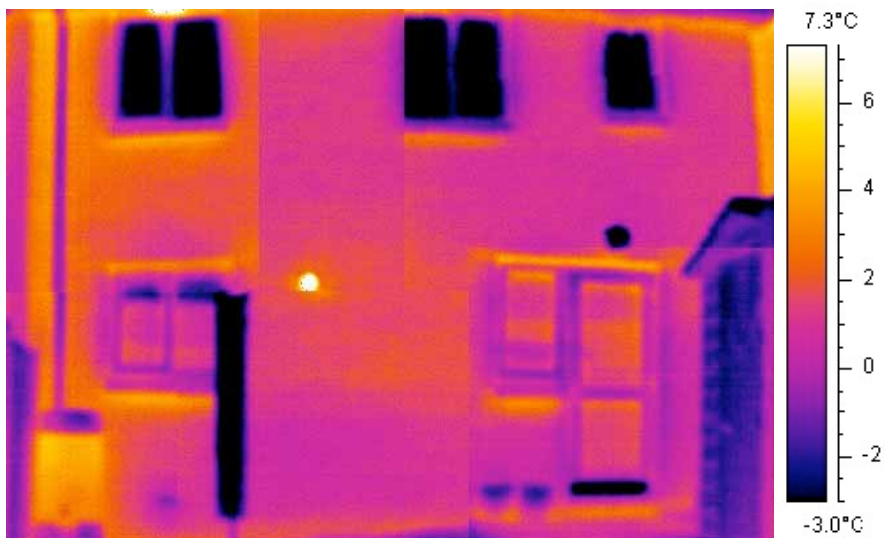
Figure 4: Thermographic image which represents the rear of Masonry House as shown in Figure 3: Colour graduation represents temperature scale of -3°C to 7.3°C .

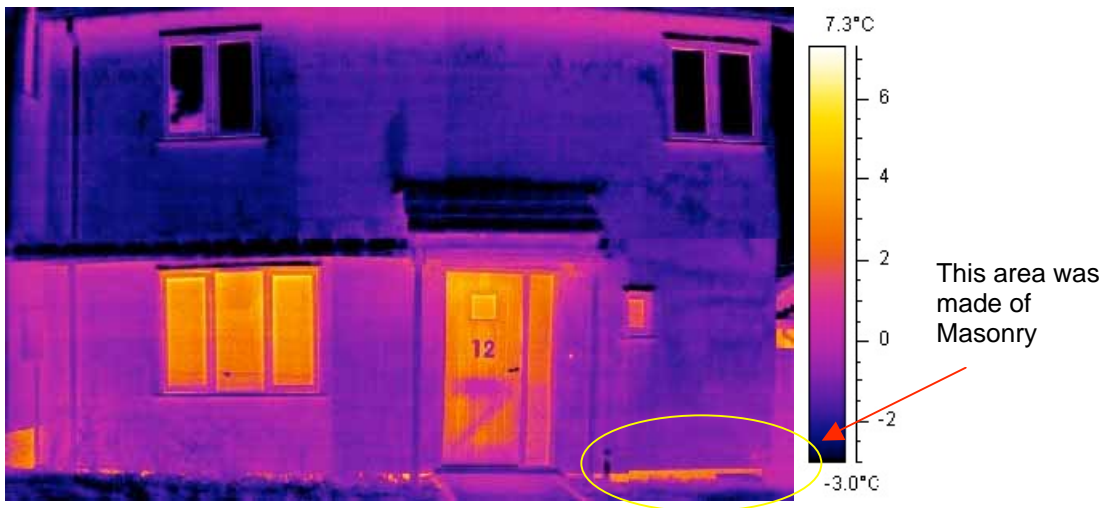
The thermographic image shown in Figure 6 indicated that in comparison to the remaining areas of walling there was significant heat loss through the section of the foundation wall below damp proof course (dpc) level immediately adjacent the right front corner of the property. It is understood that the foundation wall consists of a brick plinth built in steps and staggers with frost resistant bricks below ground. This area is not insulated. It should be noted that the ground level adjacent the wall to the left hand side of the front door shown in Figures 5 and 6, was coincident with the dpc level and not below it as on the right hand side of the door. Hence there was no indication of excessive heat loss on the left hand side of the front door shown in Figure 6 as this area of walling was hidden from the camera. Furthermore, from the thermographic image taken of the upper left hand first floor window to the rear elevation of the house, there was heat loss due to the trickle ventilation (shown in Figures 9 and 10).

Figure 6: Thermographic image which represents the front elevation of the Hemp House as shown in Figure 5: Colour graduation represents temperature scale of -3°C to 7.3°C.

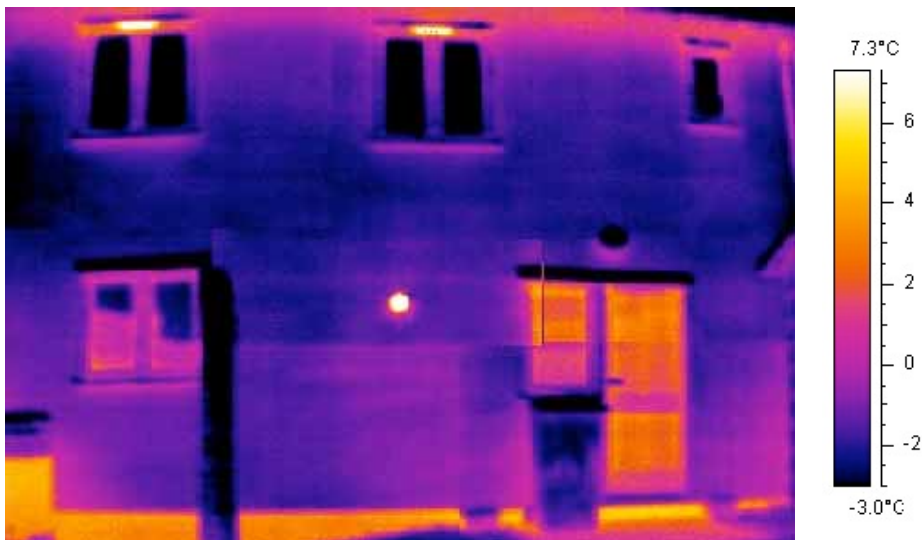
Figure 8: Thermographic image which represents the rear of Hemp House as shown in Figure 7a and 7b: Colour graduation represents temperature scale of -3°C to 7.3°C.

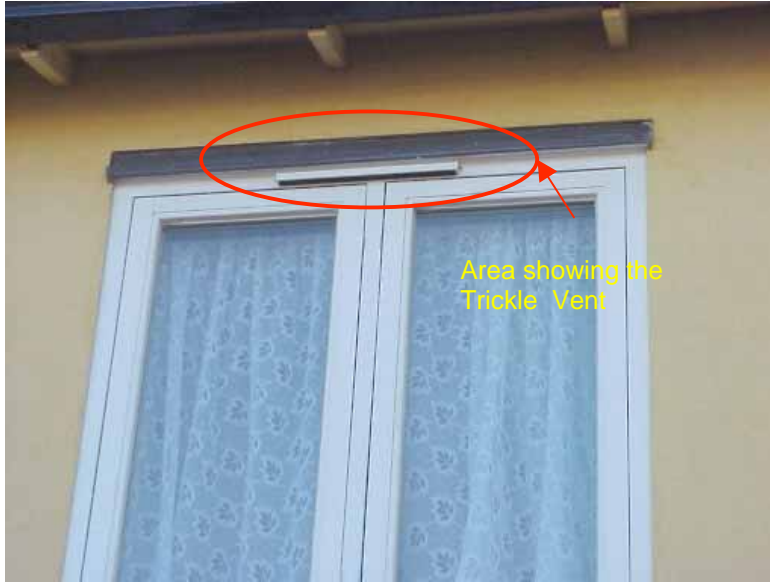
Figure 9: This photo showed the area where there was heat loss from the trickle ventilation (at the back window of the Hemp House).

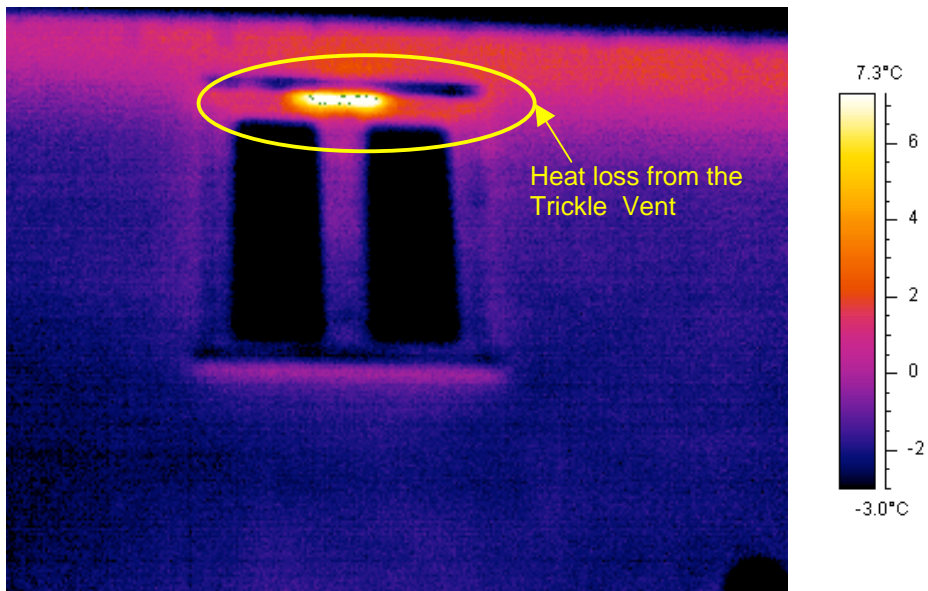
Figure 10: Thermographic image showing the area where the heat losses took place.

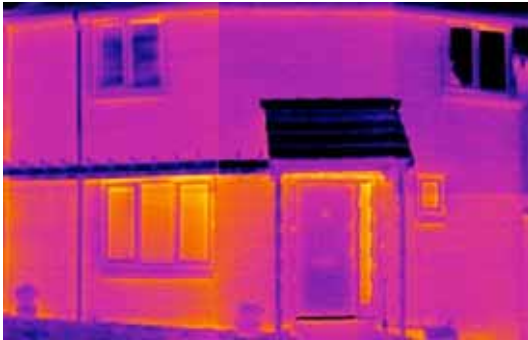
The results of the thermographic survey conducted by BRE indicated that there was a significant amount of heat loss through the external walls and windows to the Masonry House in comparison with that occurring in the Hemp House (Figures 11a, 11b, 11c and 11d). Unfortunately, a problem was encountered during the assembly of the thermographic images resulting in a slight distortion of the images of the houses. However, the completed images of the front and rear elevations to both houses clearly reveal a contrast in the thermal losses occurring in each of the two houses.

Figure 11a: Thermographic image of the front of the Masonry House.

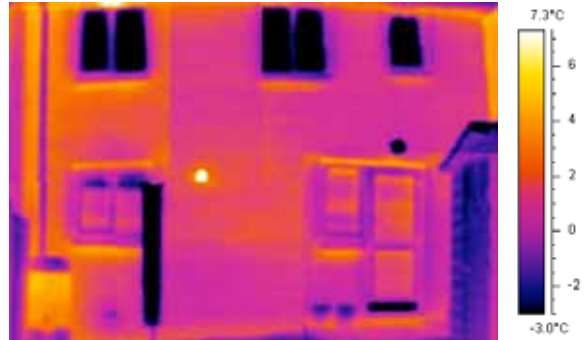
In comparing the results obtained from the survey of the Masonry and the Hemp Houses (refer Figures 11b and 11d), it appears that the temperature of the external walls to the Masonry House is slightly higher by approximately 4°C to 6°C than the walls to the Hemp House. It is assumed that the temperature of the “Balanced flue vent to the central heating boilers” in the two houses is similar and therefore can be used as a reference temperature scale for the background temperature of the two houses.

Figure 11b: Thermographic image of the rear of Masonry House

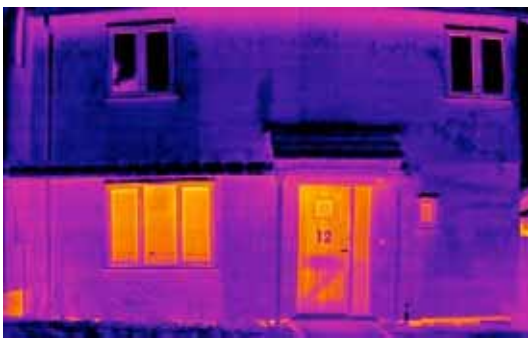
Figure 11c: Thermographic image of the front of Hemp House.

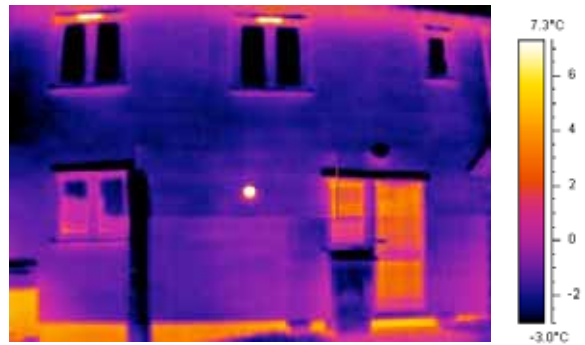
Figure 11d: Thermographic image of the rear of the Hemp House.
