Final Report on the  
Construction of the Hemp  
Houses at Haverhill, Suffolk

Client report number  
209-717 Rev.1

Steve Clarke  
Suffolk Housing Society Ltd

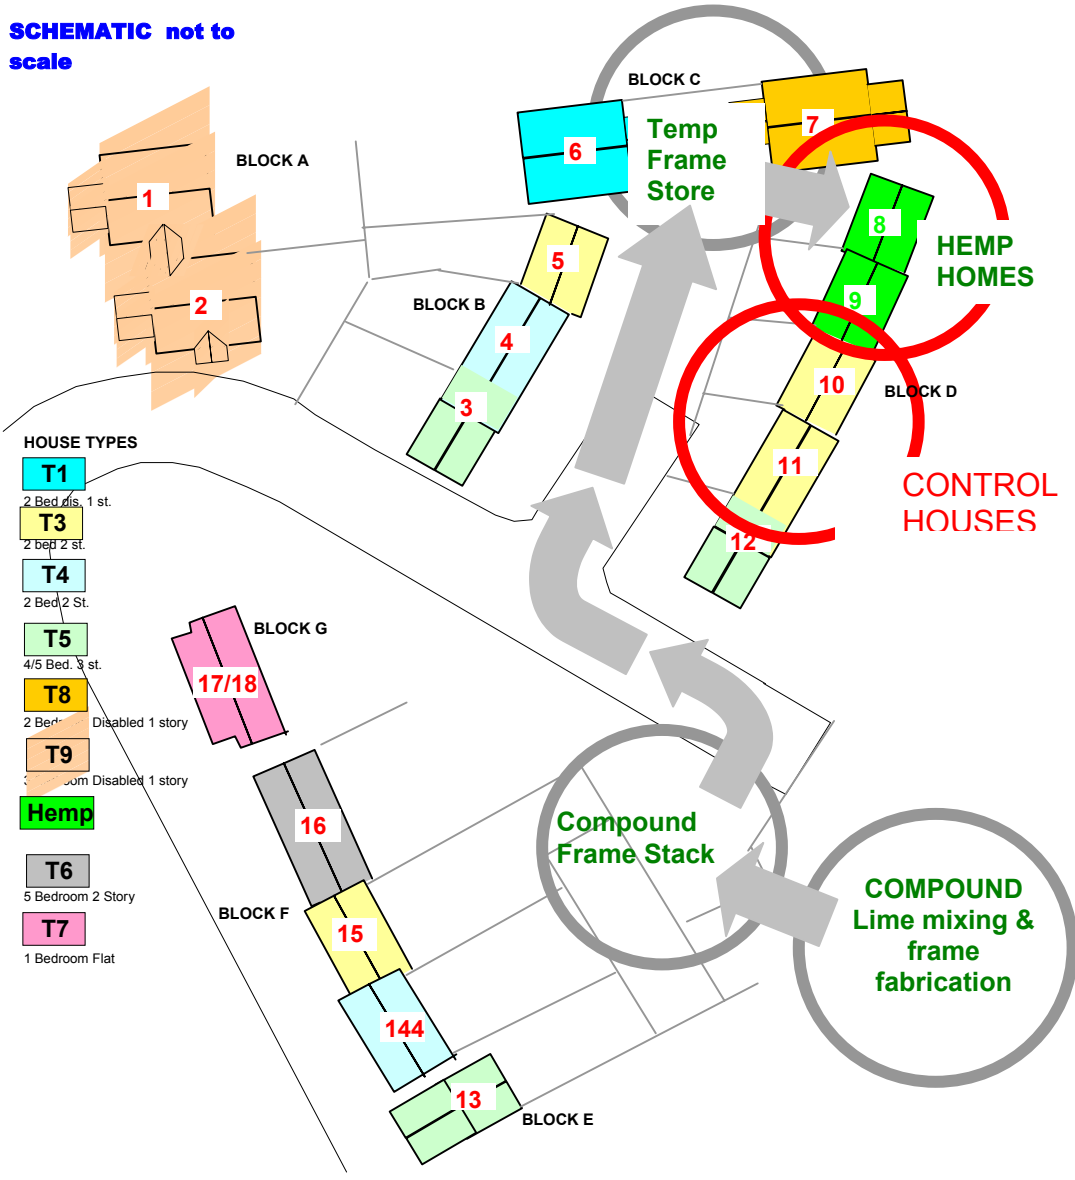
The schematic layout below illustrates the work areas for the on site fabrication of the Hemp Homes frames.

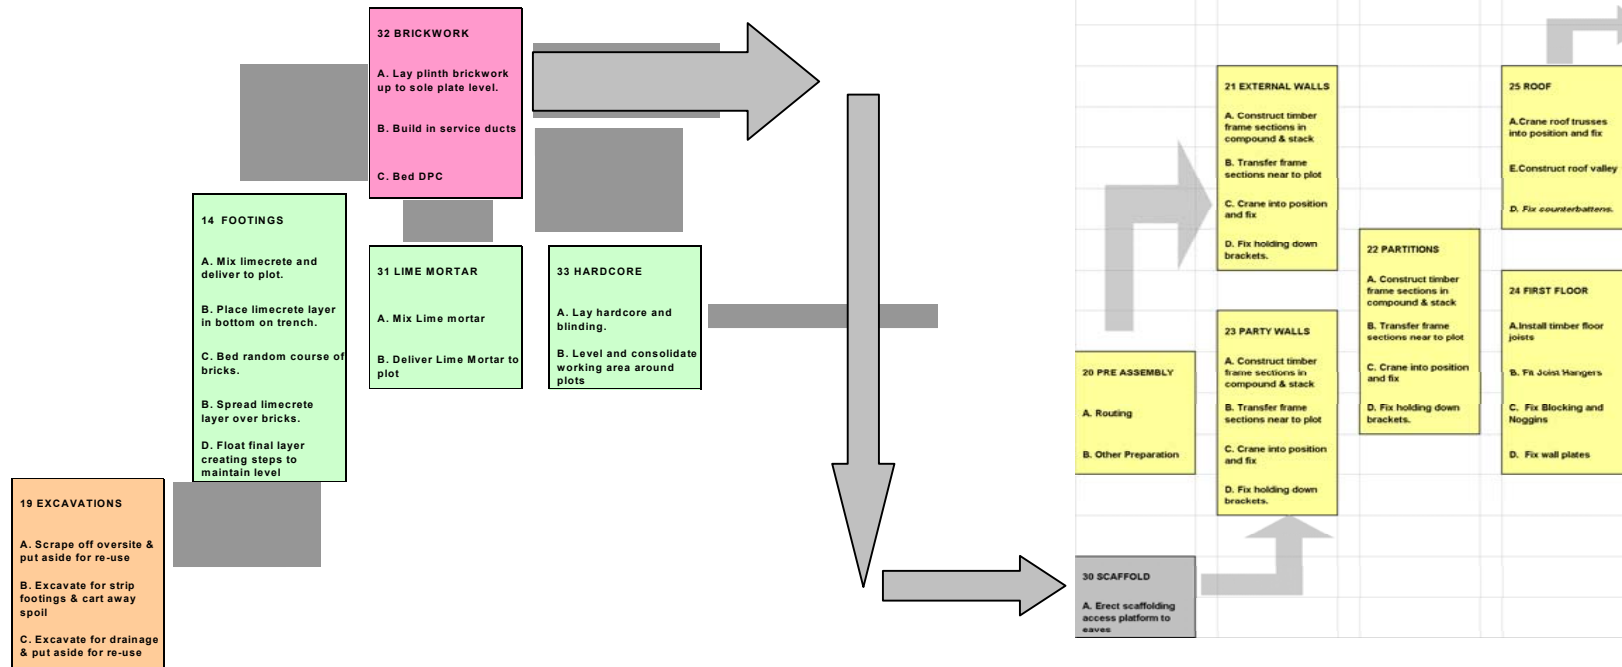
The Process Map below illustrates packages and tasks that were monitored

This diagram is the process map up to the completion of the timber frames for the Hemp Homes. Each box represents a package and contains the task level breakdown monitored on site.

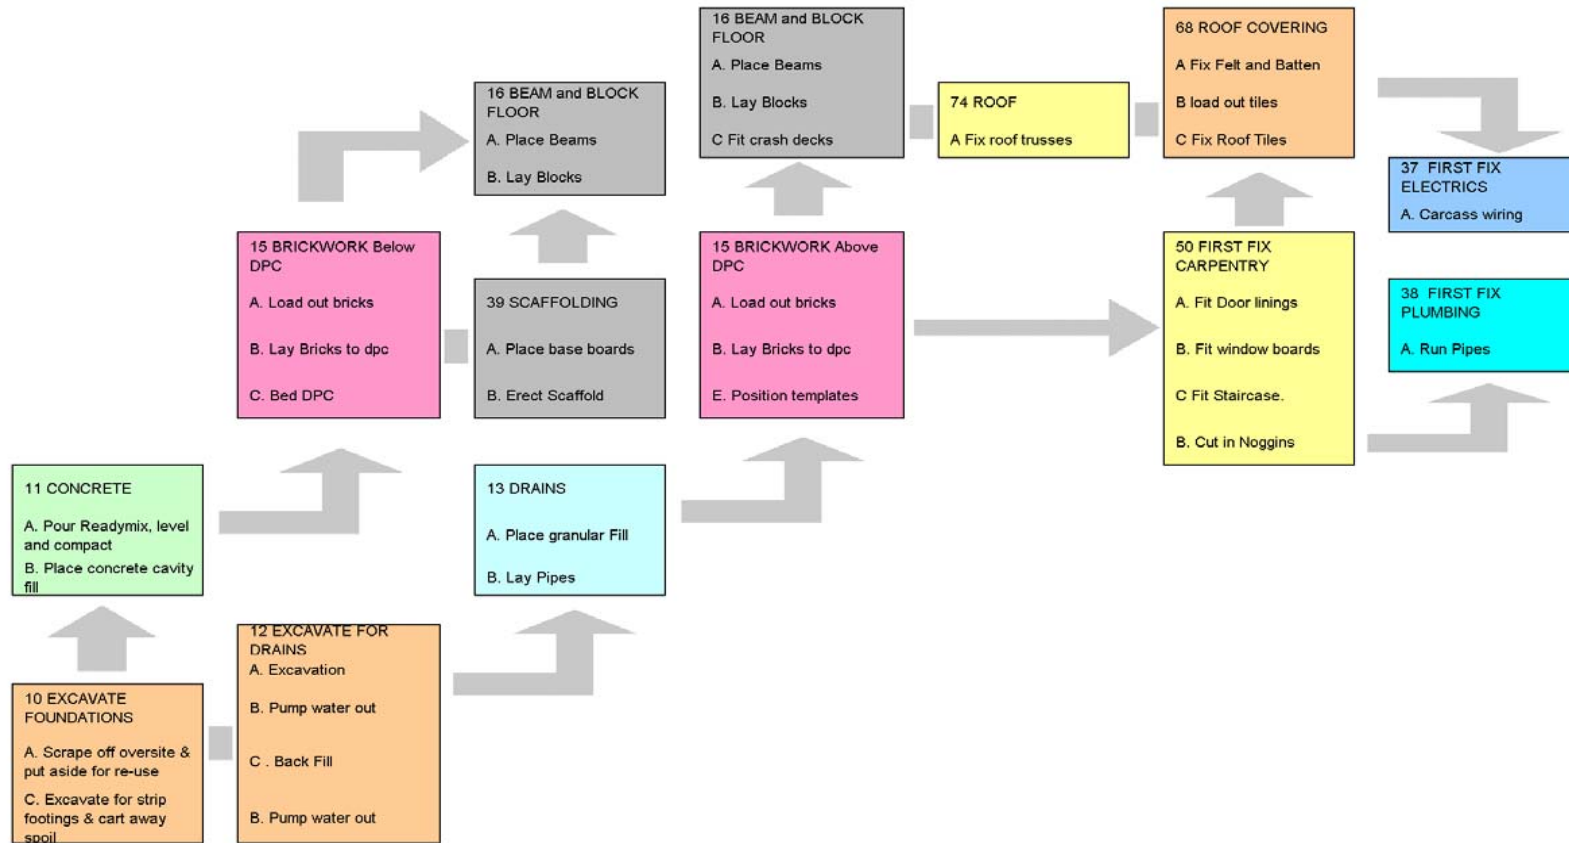
The Control Homes Processes

The Process Map below illustrates packages and tasks that were monitored

This diagram maps the processes up to the fitting out stage of the control houses, each box represents a package and contains the task level breakdown monitored on site.

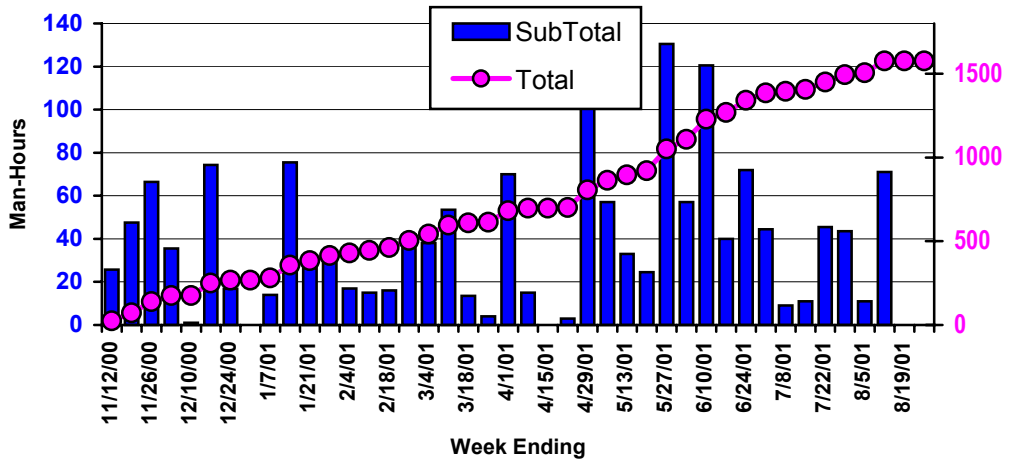
Control Homes 10 and 11

Total Man Hours Input to Hemp and Control Homes

These Histograms present the weekly recorded data for the two Hemp Homes and two Control Homes. From week-ending 12/11/00 to week-ending 26/08/01.

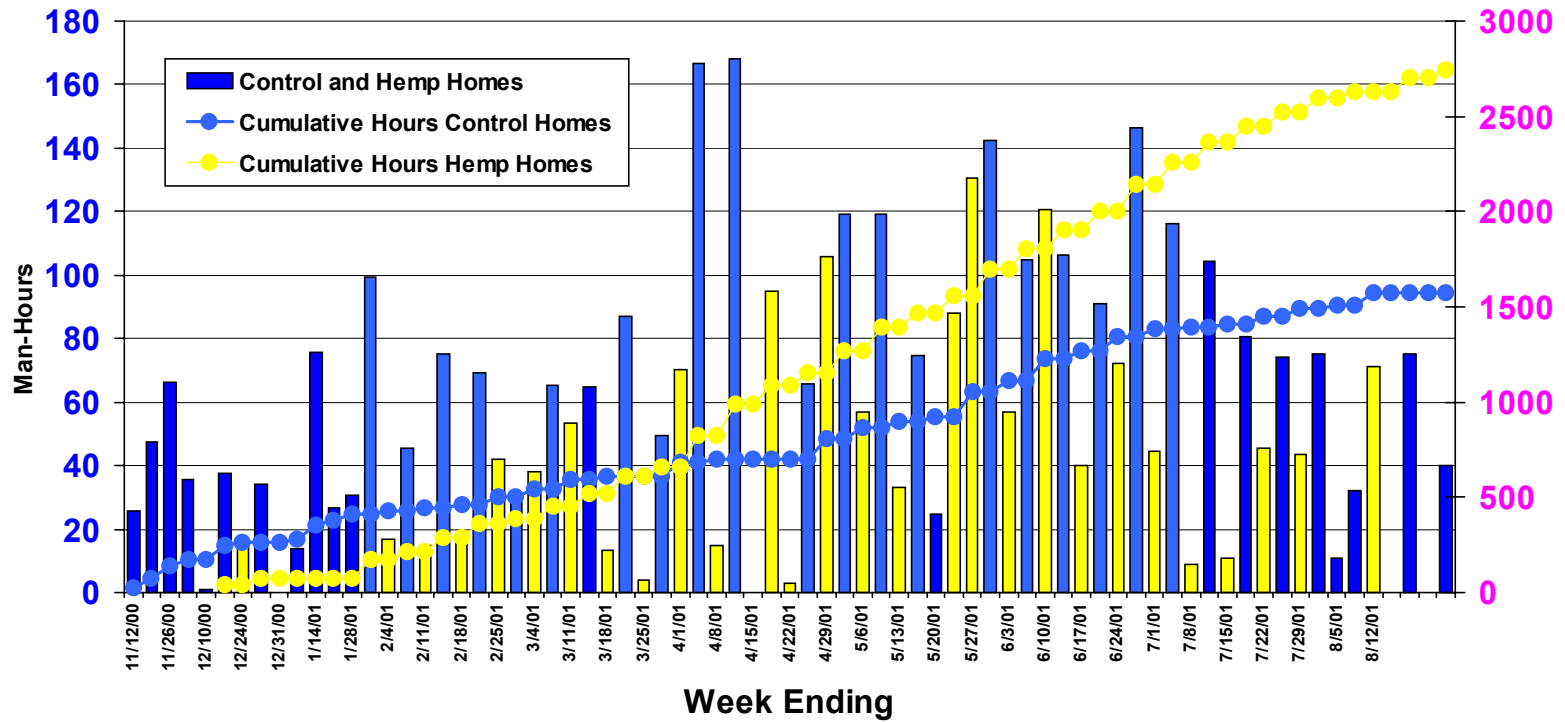
### Cumulative Man Hours Hemp V Control Homes

Comparison of Man-hours (Hemp V Controls )

The Histograms present the week-ending records of manhours up to the week-ending 26/08/01. The blue bars represent two hemp homes and the yellow bars represent the two control homes for that period monitored.

Note: These hours do not include extra hours in different location on site which might be related to these houses.

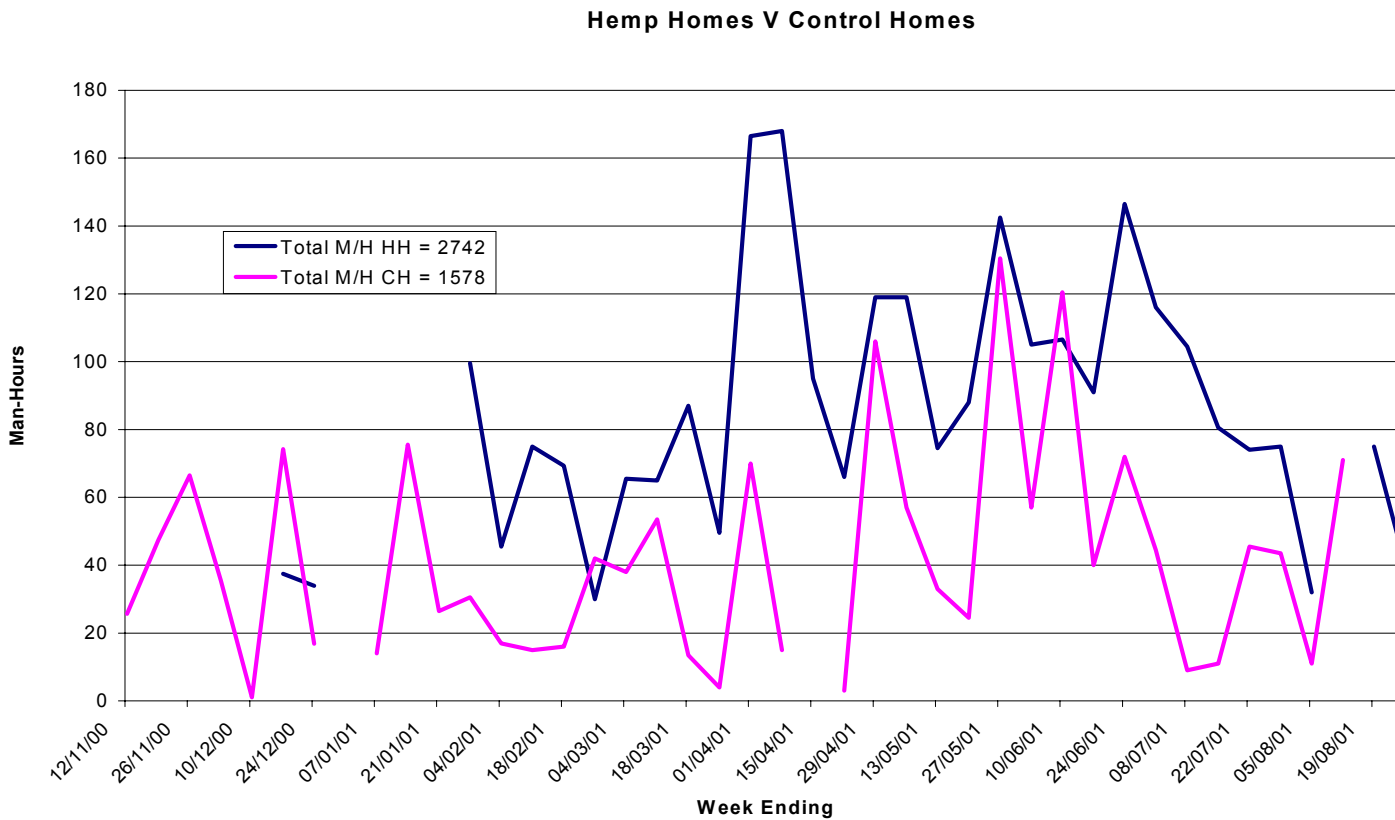
The line graph above shows the weekly man-hours spend on these specific houses (two Hemp and two Control).

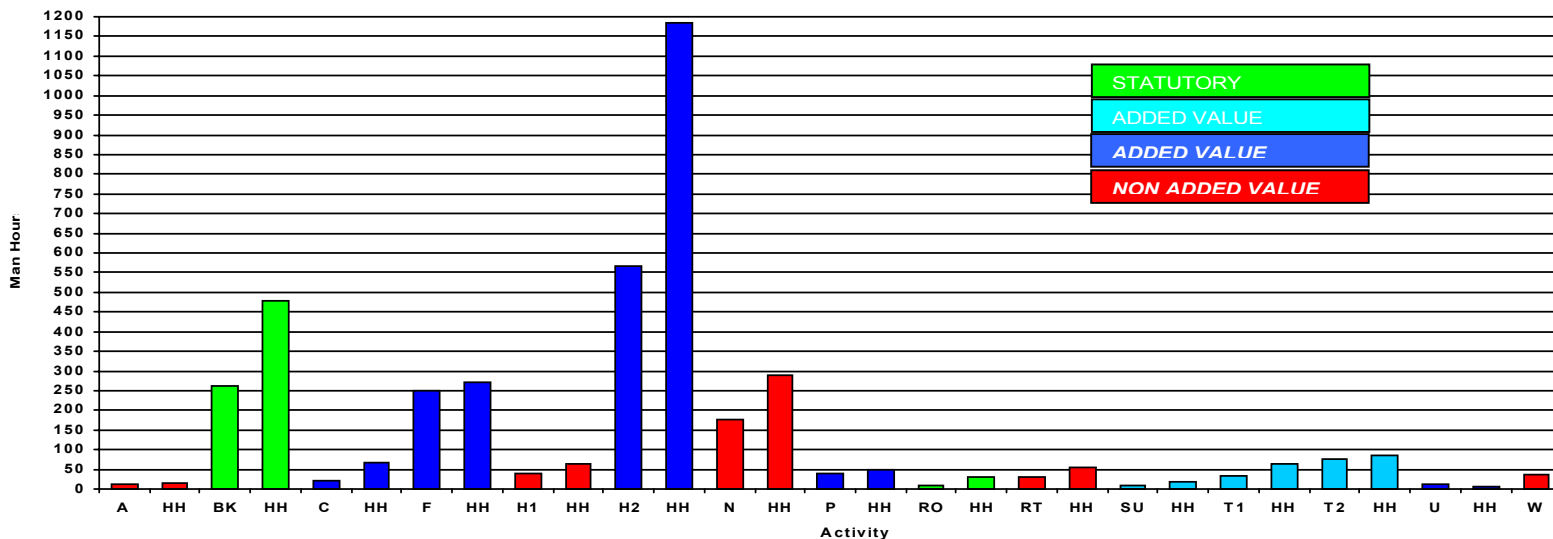
Total Activity Breakdown (Man-hours) Hemp and Control Homes

This histogram shows the number of man-hours monitored for the whole site in each of the activity categories. The columns are arranged in pairs with the left hand column of each pair representing the two control houses and the right hand column of each pair representing the two hemp houses. The right hand column of each pair is identified (HH). The left hand column of each pair is identified by the activity code which applies to both columns within the pair. These codes can be identified from the lists given earlier in The Calibre Productivity Toolkit.

The biggest work packages monitored were those of the bricklayers and they have helped to bring the non value-added percentage down from 21% to just 20%. Some notable results are 1751 Man-hours for (H2) handling at the work place, whilst 103 man-hours (H1) were recorded double handling, 90 man-hours (P) spent preparing, 262 man-hours (T1 & T2) measuring and checking, 20 man-hours (U) unloading and in the non added-value categories we also have 465 man-hours (N) not working at the work place and 85 man-hours (RT) re-work. The overall breakdowns here to the right show the actual percentages to compare with the target norms for the industry.

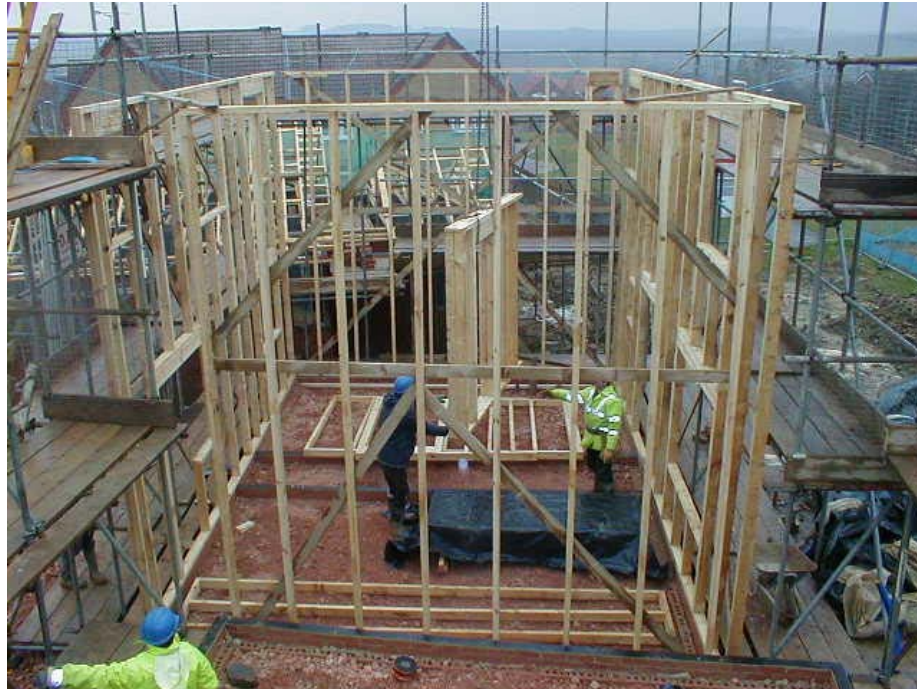
**Figure 1** The timber frame during erection.

It was found that it is easiest to build the timber frames on the ground and rear them up in sections – which are then easily joined together. The roof should be put on early in the job, but the timber frame needs temporary diagonal bracing to stabilise it until the hemp is cast. The roof covering can be put on to allow work to continue under cover and in the dry although the lower edge should not be fixed if casting at the top of the wall is not to be obstructed. It is then best to strike scaffolding as it is much easier to continue working without the obstruction it otherwise presents. Work that then needs to be done at

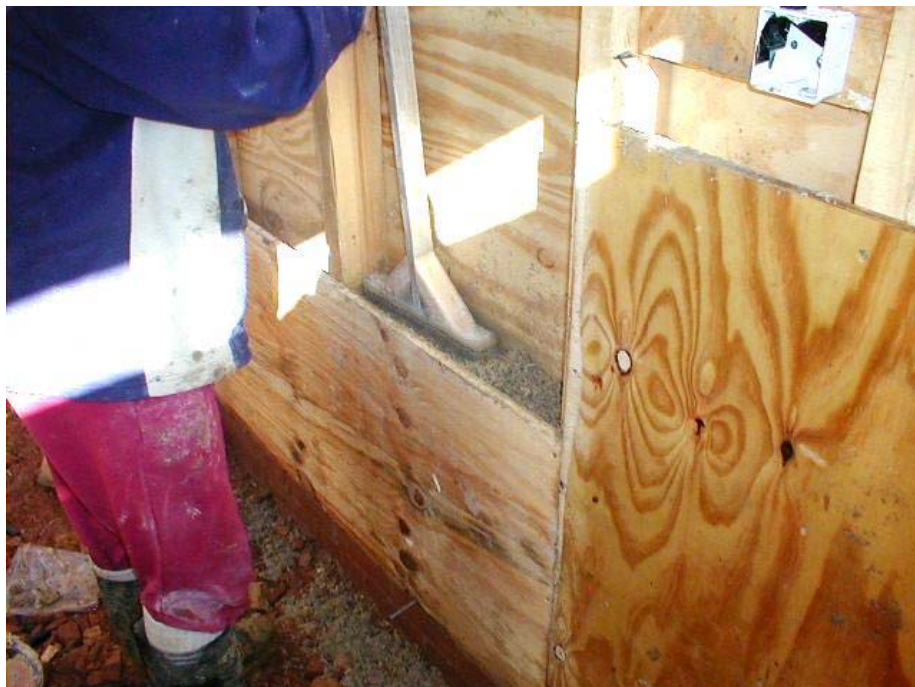
**Figure 2** Tamping the hemp/lime into the shuttering

The electrical conduits and back boxes were easy to install although the subsequent packing of the hemp around them and at awkward corners needed some care. The shuttering and casting of the hemp walling went well although it was slower than anticipated. At one stage, the special mixer had to be repaired. The supply of hydraulic lime ran out and more had to be imported from a new source in France. This occurred once the pipe-work and wiring were in place, floorboards were down and the lime skim coat was being applied in the first hemp house.

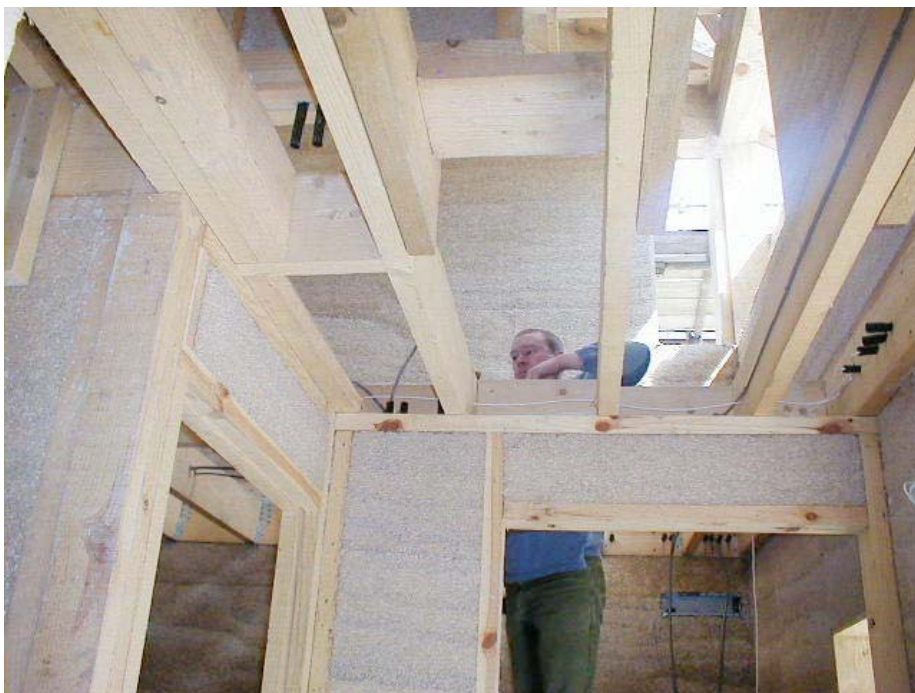
**Figure 3** Ground floor interior near the completion of the 'shell'

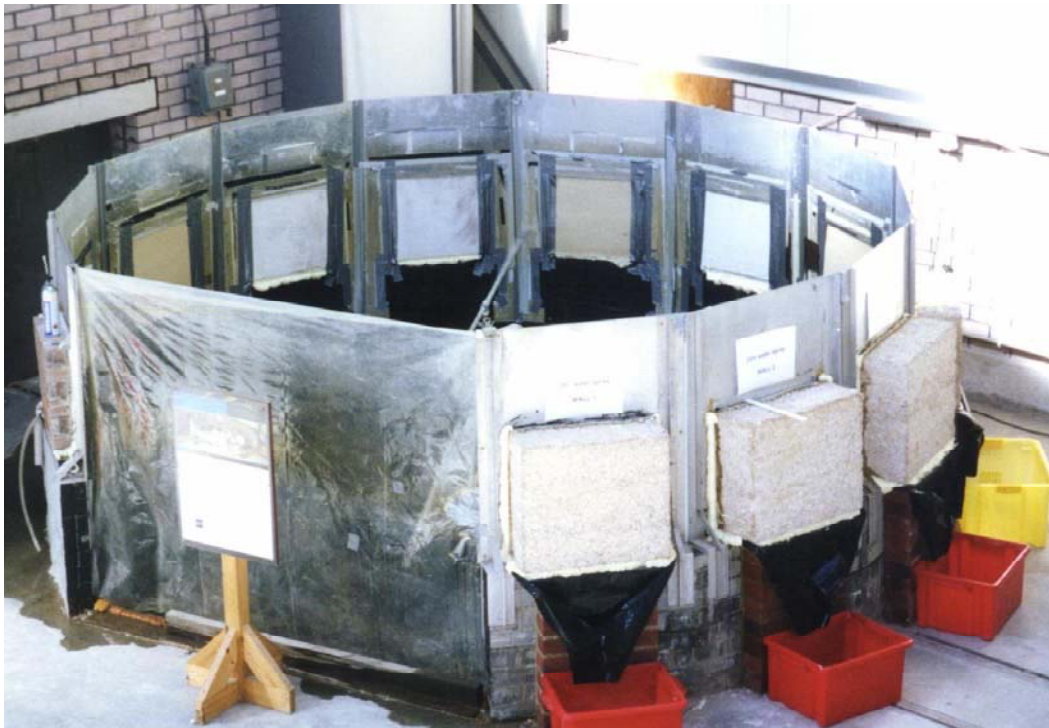
The test samples were made using a mixture of hemp and lime mortar placed in moulds to form small test walls of dimensions 500x500x200mm. Four walls were made for testing and left for a period of several months before a 10mm coating of lime mortar render was applied. The render, when dry, was noted to have cracking which was repaired by filling the cracks with lime paste. After the paste had fully dried and cured, over a period of several weeks, the render was given a brush applied limewash coating. The test samples were then placed in position on a water spray rig (Figure 1) to test the resistance of the material to water penetration from simulated wind driven rain.

The spray apparatus was developed to test, in simulated conditions of severe driving rain, both the effectiveness of water repellents on building materials and the leakage through the mortar joints of masonry walls

Figure 8. Hemp walls (foreground) positioned on water spray rig

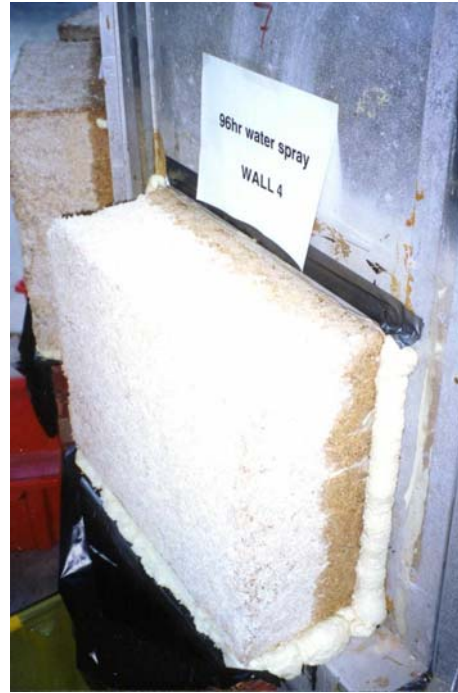
- After 2 hours water spray no water absorption (visible dampness) was observed within the hemp walls (behind the rendered face) for each of the four test walls.
- After 24 hours water absorption (visible dampness) was observed within the hemp walls to an average depth of 20 – 40mm behind the rendered face of each test wall (see Figure 2).
- Beyond the first 24 hour water spray period the depth of water absorption for each subsequent 24 hour period further increased by approximately 10 – 15mm.
- After 96 hours, at the end of the water spray test, water absorption was observed within the hemp walls to an average depth of 50 – 70mm behind the rendered face of each test wall (see Figure 3).

Figure 10. Water absorption depth after 96 hour water spray

The results indicate that provided the render coating remains well adhered and crack free it is unlikely that rain penetration will transverse the complete thickness (200mm) of the hemp/lime mortar wall.

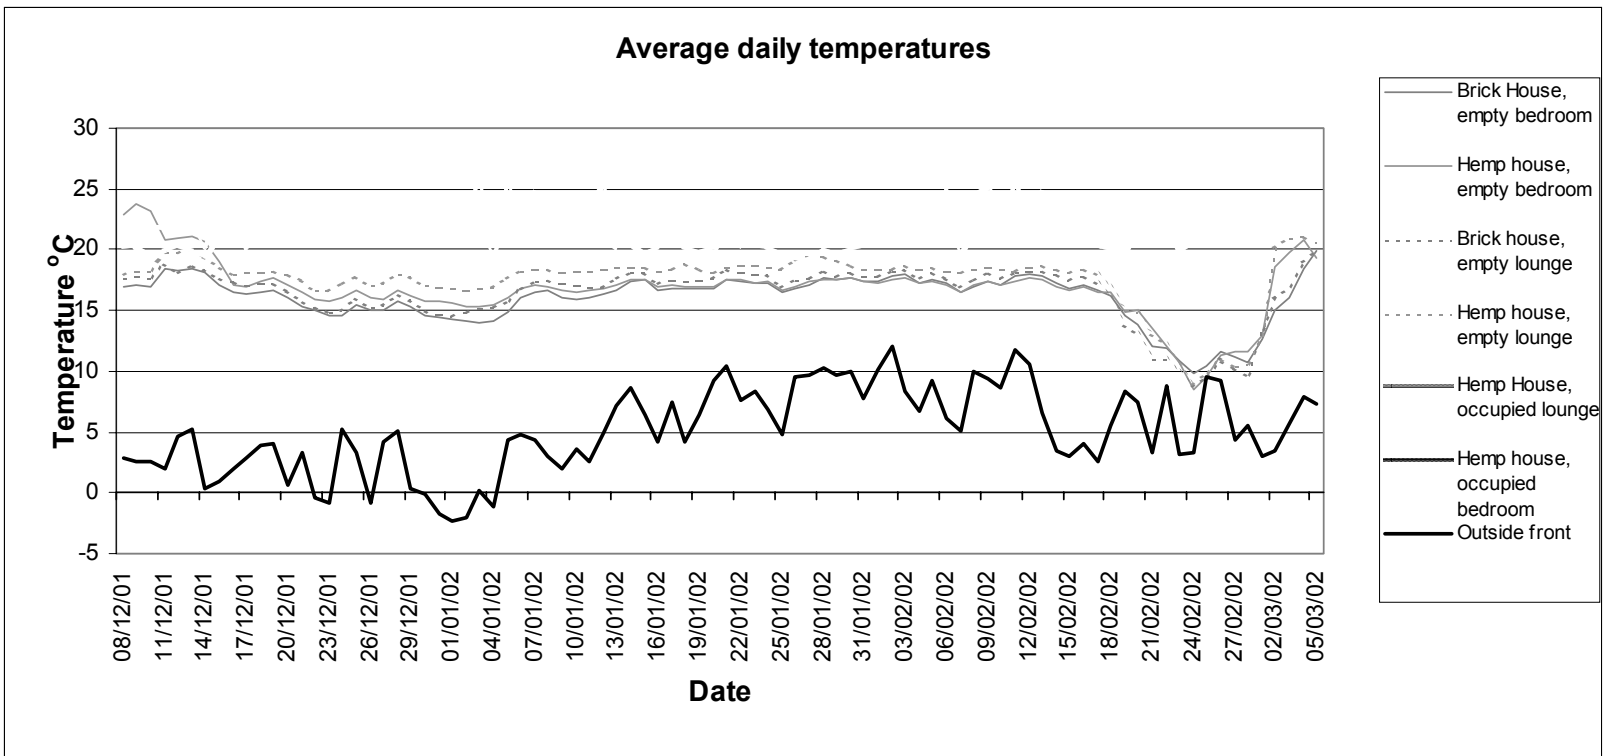
The temperature and humidity were monitored in all four houses – two traditional and the two hemp houses - during a four month period from December 2001 to April 2002. This period included three months during which one hemp house and one brick house remained unoccupied.

Looking at the data collected using thermal and humidity loggers we find that the temperatures maintained in the hemp houses have been consistently one or two degrees higher than in the brick houses for the same amount of heat input.

Figure 11. Graphical summary of the temperature readings at Haverhill

Looking at the data collected by BRE using thermal and humidity loggers we find that the temperatures maintained in the hemp houses have been consistently one or two degrees higher than in the brick houses for the same amount of heat input. At a temperature of 19°C people can be very sensitive to even half a degree difference and once the tenants are familiar with the way their houses work it is likely that they will start to adjust their radiators to deliver comfort conditions more efficiently. This should reduce the overall energy consumption in the hemp houses.

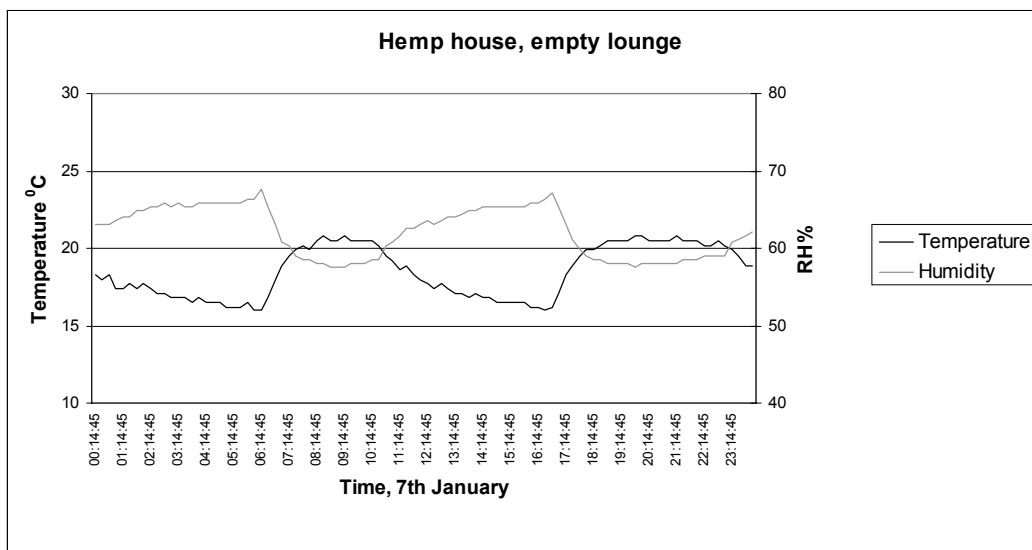
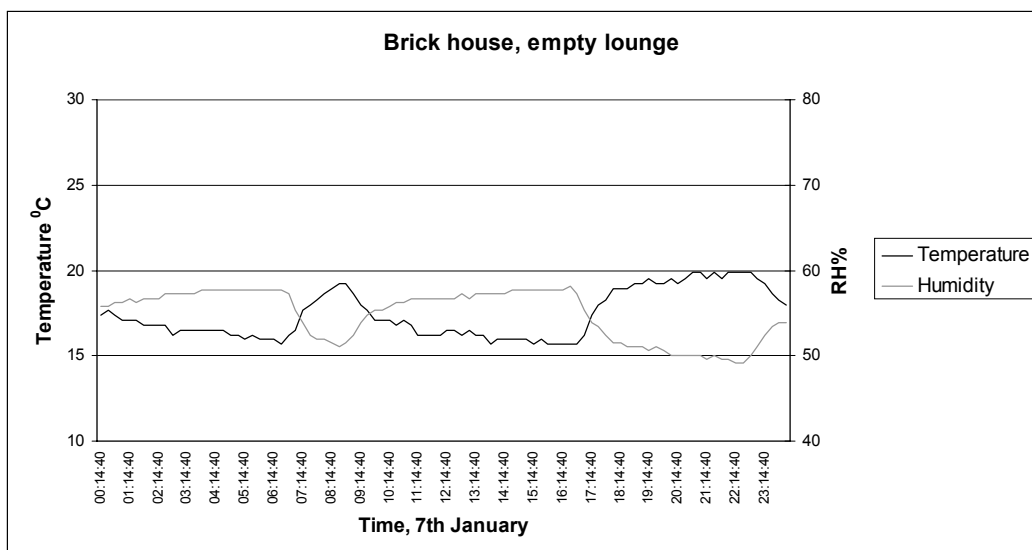
Figure 12. Comparison of the temperatures and humidities in the lounge of the traditional brick house and the hemp house – 7<sup>th</sup> January 2002

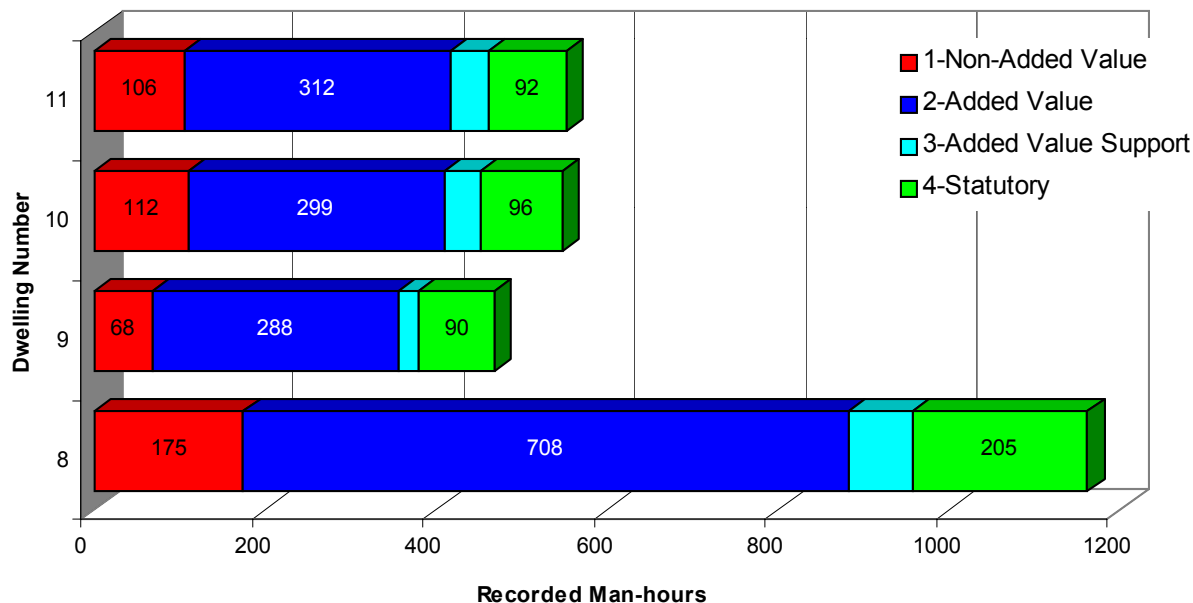
The labour input for the construction of the two types of house at Haverhill as summarised in the following diagram.

The reduction in the time taken to construct House 9 is due to two factors. The first is that House 8 has a gable end which increases the amount of construction work. The second and more important is that it is clear that the builders 'learned' on the first house and were able to put this into practice on the second one – it is reasonable to expect some further savings (in time and labour costs) if more houses had been constructed using hemp.

[Note the total for house 9 is probably underestimated by around 60 hours because the fitting out was not complete at the time the recording stopped – but this still makes the time very comparable with the 'traditional houses'.]
