E. Pihl & Son Headquarters, Lyngby

Building Description

NatVent Case Study Summary

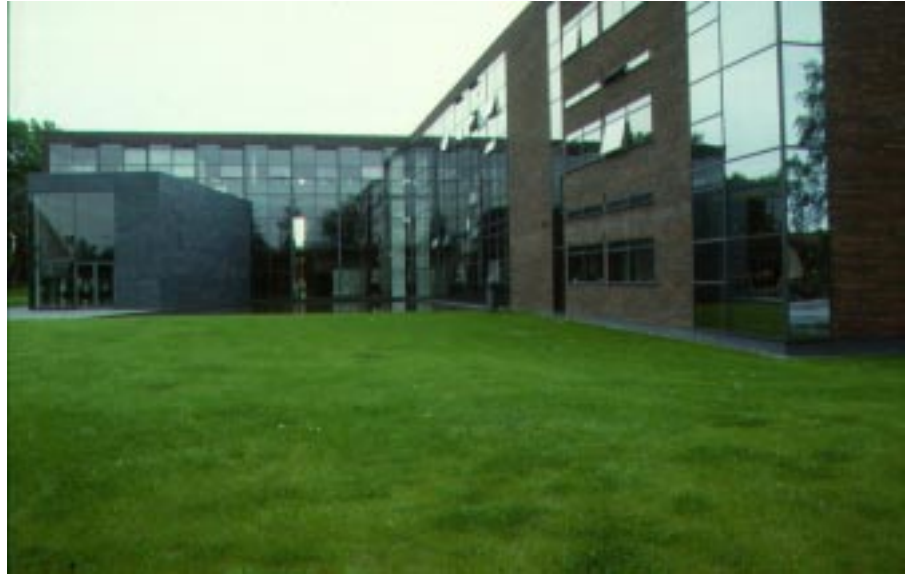
Figure 1: Outside View of Headquarters Building

The company Headquarters of E. Pihl & Son (one of Denmark's major contractors) is located in relatively quiet surroundings in Lyngby about 10 kilometres north of Copenhagen City. Completed in 1993/94, the building is, in concept, a three-storey office building angled in a diagonal symmetry in which the sides of the angle reflect each other. The corridors are skylit galleries and formed as a panopticon space. A canteen extends out from one of the wings. Figure 1 illustrates the north-west facade of one of the office wings.

The offices are naturally ventilated, the main components being specially designed multi-position ventilation openings in the offices and openable skylights in the corridors. Figure 3 illustrates a sectional view of one of the office wings including idealised air flow paths. The ventilation openings in the offices are located in distinctive narrow window bands above the ordinary windows, as shown in Figures 1 and 4.

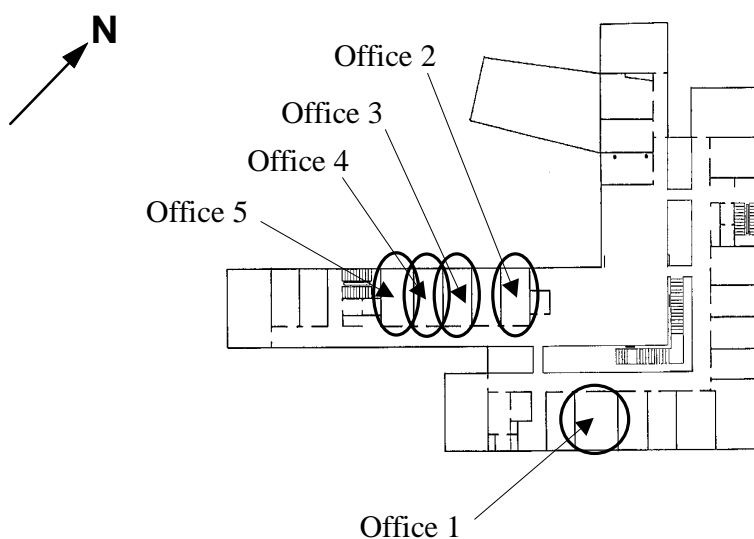
Figure 2: Typical Floor Plan Showing Offices Monitored

Figure 2 shows a typical floor plan. The floor area is about 2,700 m² and the building volume is 8,000 m³. About 2,000 m² (75%) is used for offices and meeting rooms, 400 m² (15%) is circulation area and the remainder is toilets and

Five offices on the second floor were chosen for the investigation, as identified in Figure 2. Office 1 is a relatively large cellular office (20 m²), office 2, 3 and 4 are cellular offices of equal size (14 m²) and office 5 is a larger office (16 m²) accommodating two people. Offices 1, 2, 3 and 5 were included in the summer monitoring exercise. In the winter monitoring exercise, offices 3, 4 and 5 were investigated as well as the corridor adjacent to the offices.

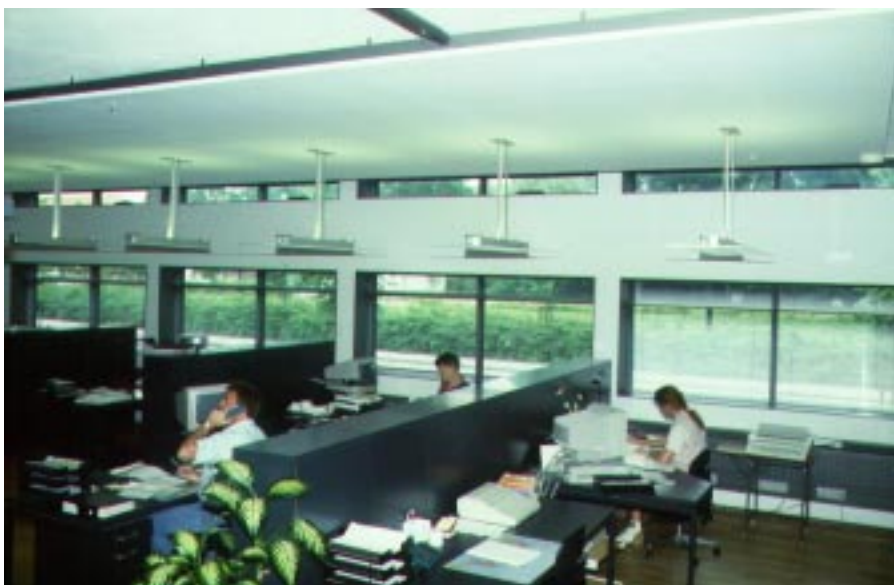
Figure 4: View From Inside an Office Illustrating Narrow Window Bands Above the Main Windows

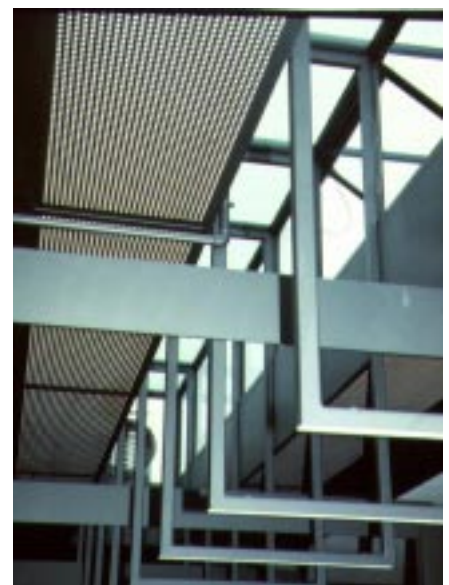
Figure 5: Location of Extract Fan and Open Roof Light

In order to take advantage of night time cooling and outdoor air supply, the ventilation openings and the openable windows in the skylights are motorised and automatically controlled via temperature sensors. Two extract fans, located on the roof of the building as an integrated part of the skylights, are intended for use in case the natural driving forces are insufficient. The fans are activated when the internal temperature reaches 26°C (Figure 5).

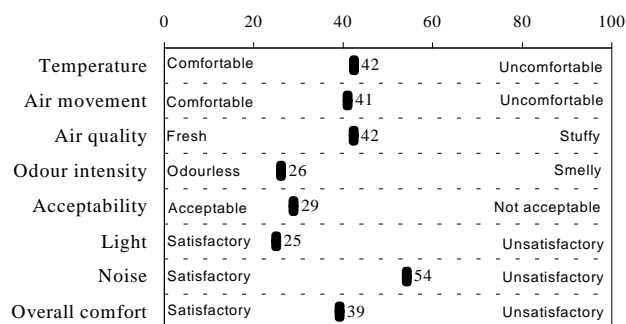
Figure 8: Occupant Reactions: Summer

Figure 8 summarises the ratings of various environmental conditions from about 50 occupants during the summer monitoring period. Even though the night cooling arrangement, in general, did not perform as intended, the occupants expressed only limited dissatisfaction with the thermal environment. Presumably, the occupants themselves, together with the manager in charge of the technical installations, were able to manually control both the ventilation openings and the internal

Comparing Figure 8 and Figure 9 indicates that the occupants rated the indoor environment in the winter to be more comfortable than in the summer.

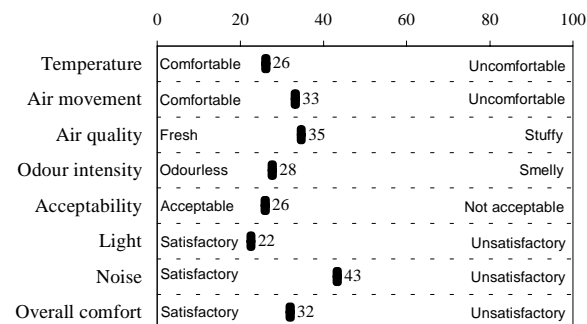
Figure 9: Occupant Reactions: Winter

Figure 9 summarises the occupants' ratings of various environmental conditions in their office during the winter season. About 75 occupants responded.
