BRF-kredit Headquarters, Lyngby

Building Description

NatVent Case Study Summary

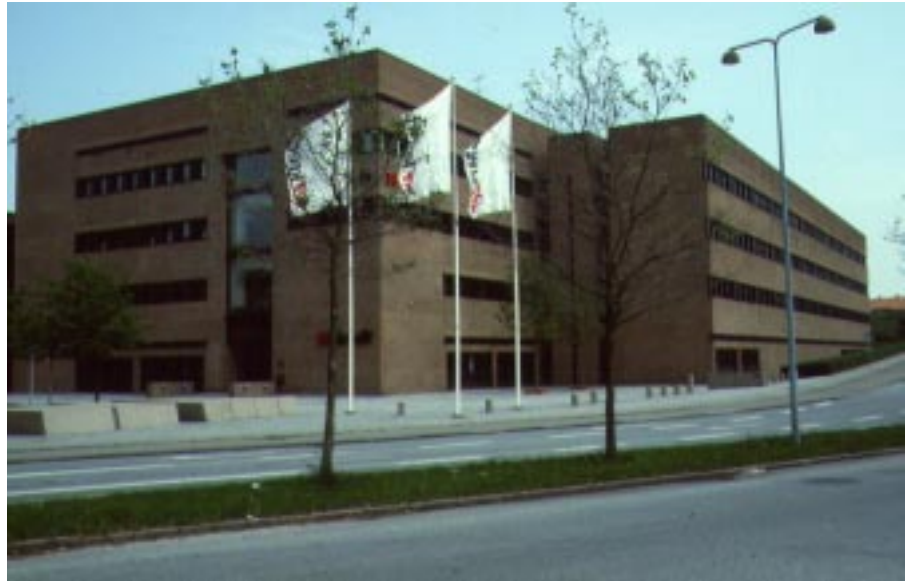
Figure 1: View Showing Main Building in Foreground and Office Block 2 on Right

This building is located in Lyngby about 10 kilometres north of Copenhagen City. It is the headquarters of BRF-kredit, a financing institute for property mortgages. The building, constructed in 1986, is a four-storey office complex, consisting of a main building and three interlinked office blocks. Figure 1 illustrates the main building and the first of the three office blocks. The main building is exposed to a moderately busy road whereas the three remaining office blocks face quieter surroundings.

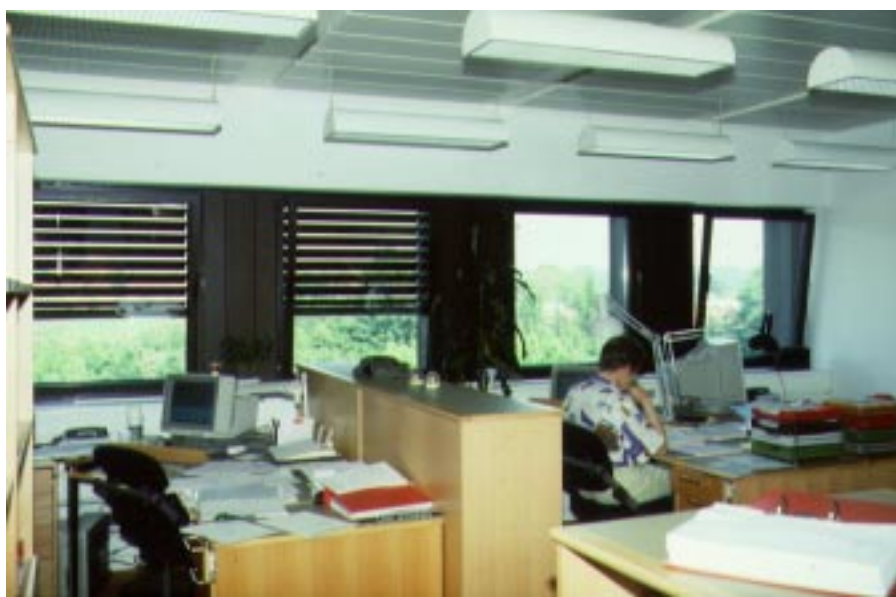
Figure 4: Interior of an Office Showing Exterior Blinds and Multi-Position Windows

Both the skylight fabric shading and the venetian blinds are controlled automatically through the use of light sensors. The venetian blinds can also be operated manually on an individual basis. The manual over-ride is not permanent and reverts to the automatic setting after a time. Figure 4 shows a section of the interior of a typical open plan office.

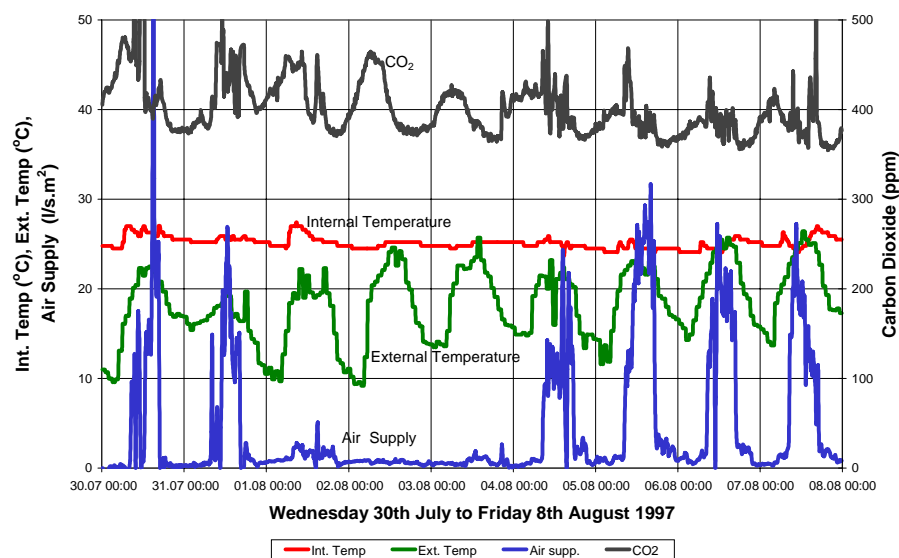
Figure 5: Summer Monitoring Results in Office 2

Figure 5 shows results for approximately one week of monitoring in office 2. The weather for this week was more typical for summer than the exceptionally hot weather described above. The results of the monitoring of the outdoor air supply in the office shows substantial air supply during the day. Despite being able to leave the office window open at night, the night-time ventilation rate is much reduced. This is because the windows are only left slightly open and the interior doors are locked shut. As there are no grilles in the

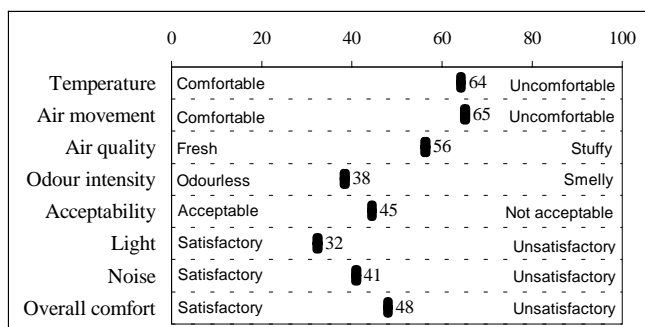
Figure 7: Occupant Evaluation (Summer)

Figures 7 and 8 summarise the occupants' ratings of various environmental

conditions in their office during the summer (Figure 7) and winter (Figure 8). About 100 occupants responded.

A comparison of Figures 7 and 8 shows that occupants felt that the indoor temperature and air movement were more comfortable in winter than in summer. With regard to air quality, the occupants apparently rated the summer situation more positively. The ratings are done on
