Zevenhuizen Town Hall, Zevenhuizen, ZH

Building Description

NatVent Case Study Summary

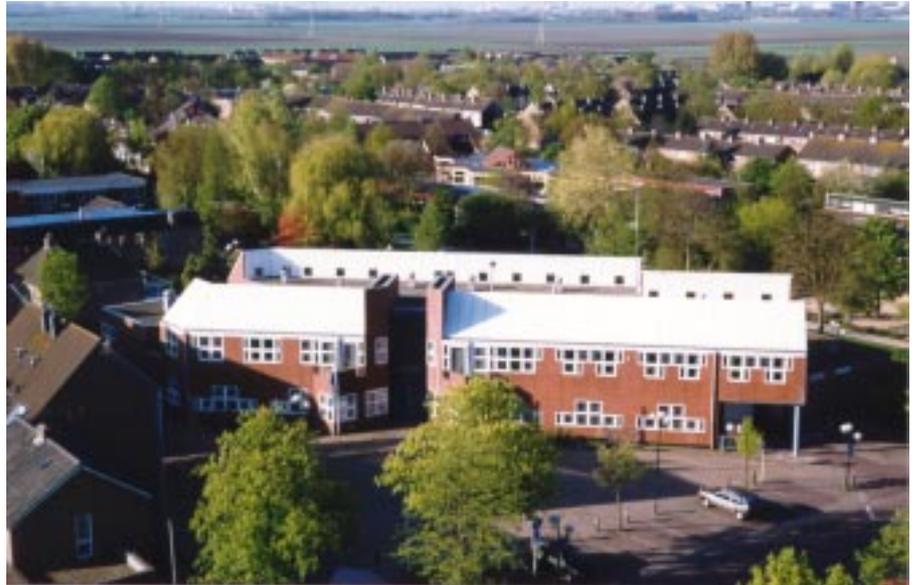
Figure 1: View of Zevenhuizen Town Hall

Zevenhuizen Town Hall (Figure 1) was built in 1987 and is owned by the municipality of Zevenhuizen. It comprises two storeys and has a total floor area of 1400 m² and a volume of 4200 m³. The orientation of the building is N-S. There are various types of room including rooms for the mayor and aldermen, a meeting room and various offices for two to five people. Currently there are about 50 people working in the building but this number is increasing.

The building is a well insulated, low energy building of high thermal mass construction. The floors and roof comprise 0.25m thick concrete, the dividing walls between the corridor and hall are made from 0.15m thick concrete, and the dividers between rooms are gypsum plasterboard. In the hall and corridors the thermal mass of the ceiling and floor are exposed, but the office rooms have lowered ceilings and carpeted floors. The roof and facades are insulated with polystyrene foam.

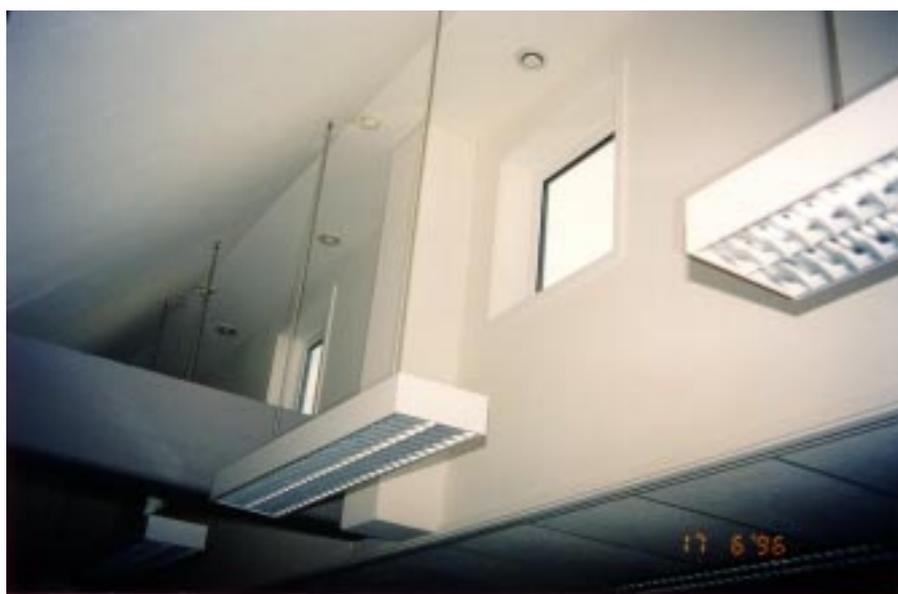
Figure 3 Daylighting Window Near the Intake Ducts of the Exhaust Channel

The intake ducts of the exhaust channels are situated in the ceiling near the daylighting windows, see Figure 3. The mechanical ventilation system has three speeds: the lowest is used for minimum ventilation in winter and the highest is used in summer for night cooling.
